**Gypsum in Minoan Architecture: Exploitation,
Utilisation and Weathering of a Prestige Stone**

Vol.I: Text

STEPHANIA CHLOUVERAKI

Institute of Archaeology

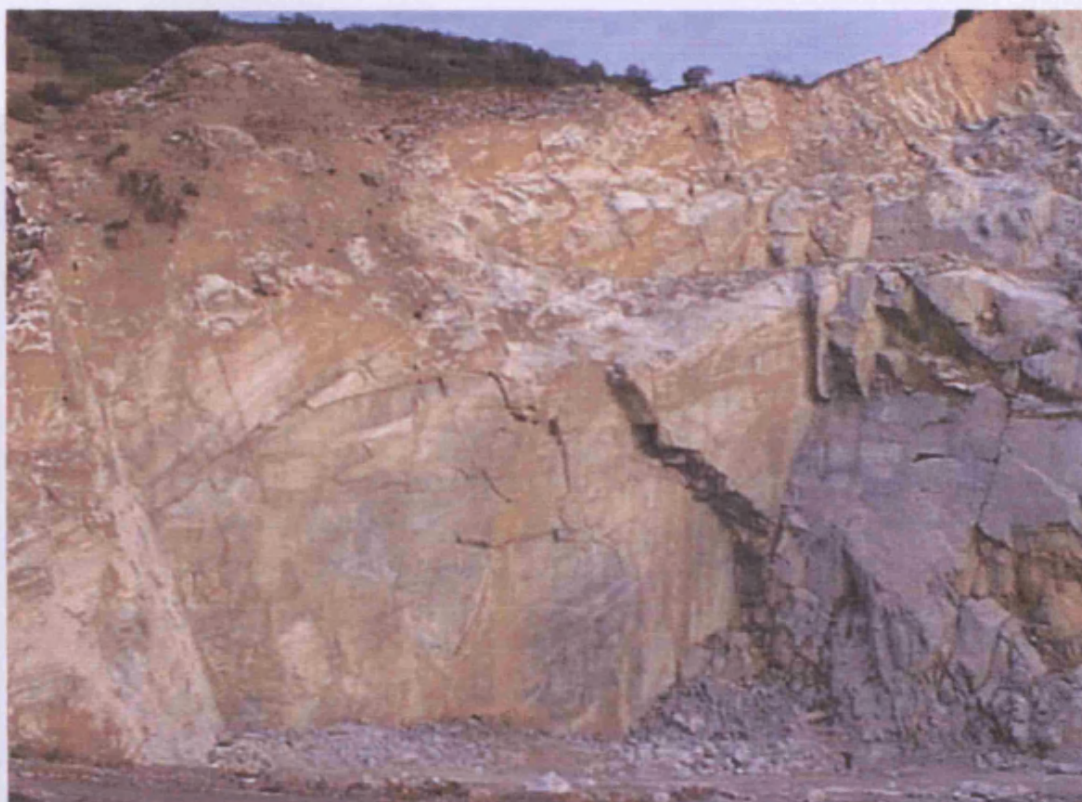
Fig.3.5: Permian outcrop of gypsum at Altsi, east Crete

Fig.3.5: Permian outcrop of gypsum at Altsi, east Crete

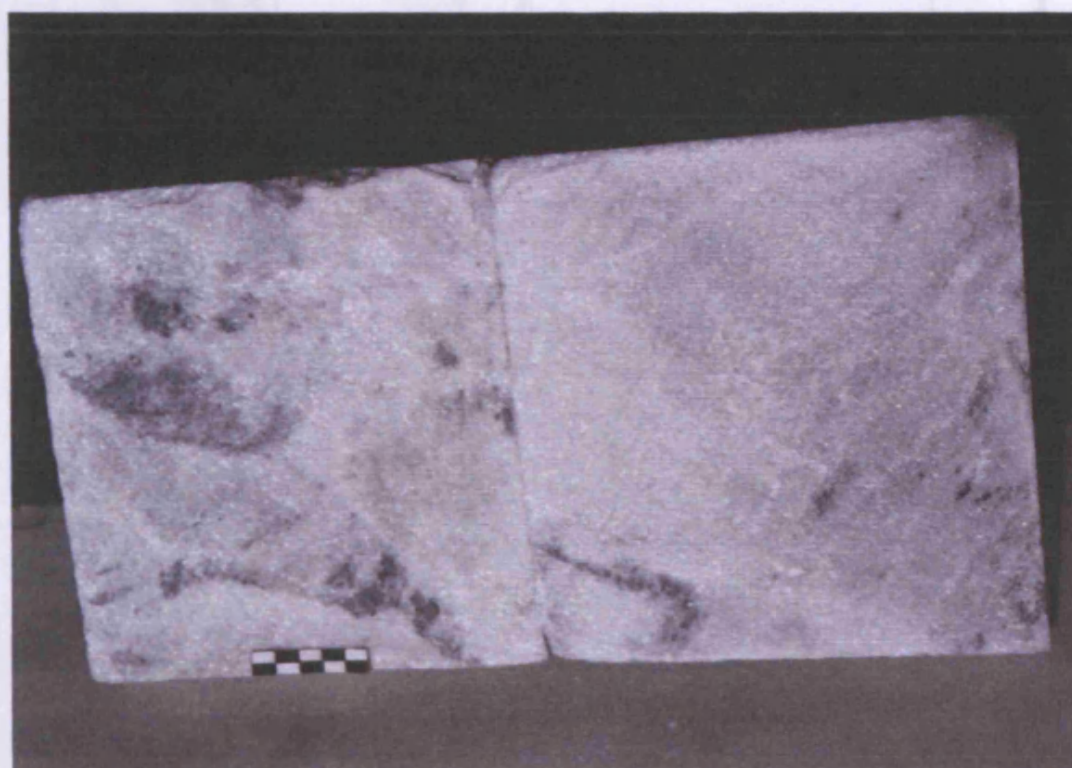
Fig.3.6: Permian gypsum from the outcrop of Altsi

Fig.3.6: Permian gypsum from the outcrop of Altsi

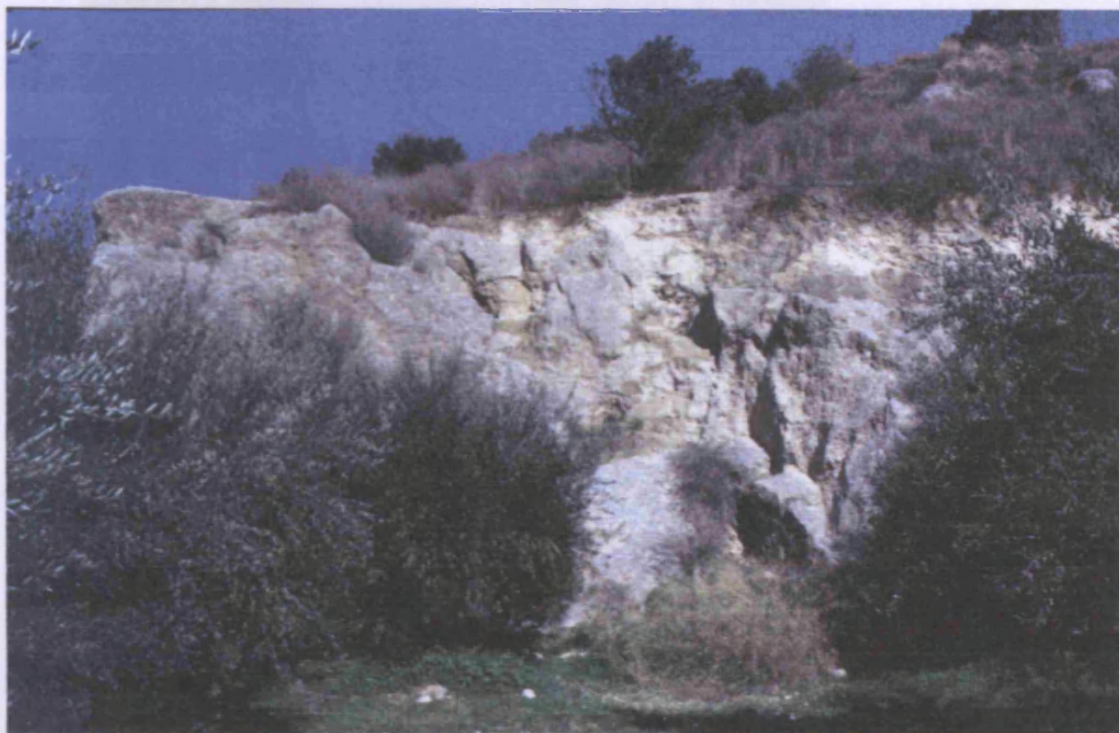
Fig.3.8: Neogene outcrop of macrocrystalline gypsum (selenite) at Gypsades

Fig.3.8: Neogene outcrop of macrocrystalline gypsum (selenite) at Gypsades

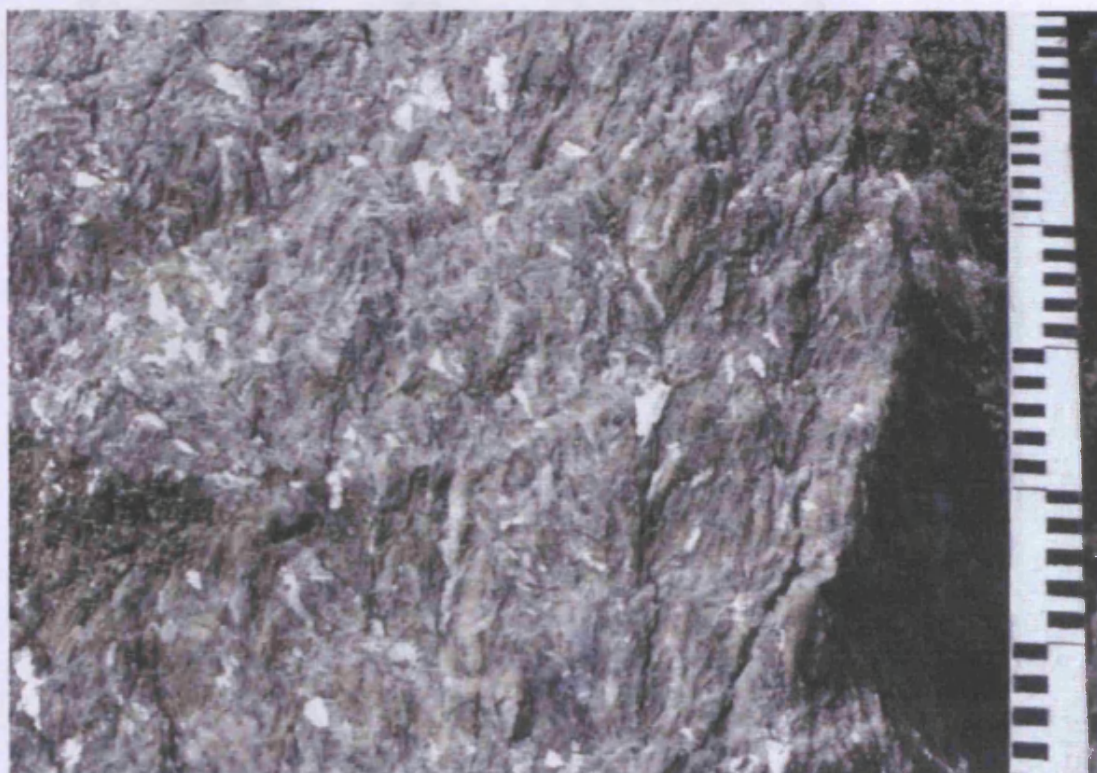
Fig.3.9: large transparent selenitic crystals

Fig.3.9: large transparent selenitic crystals

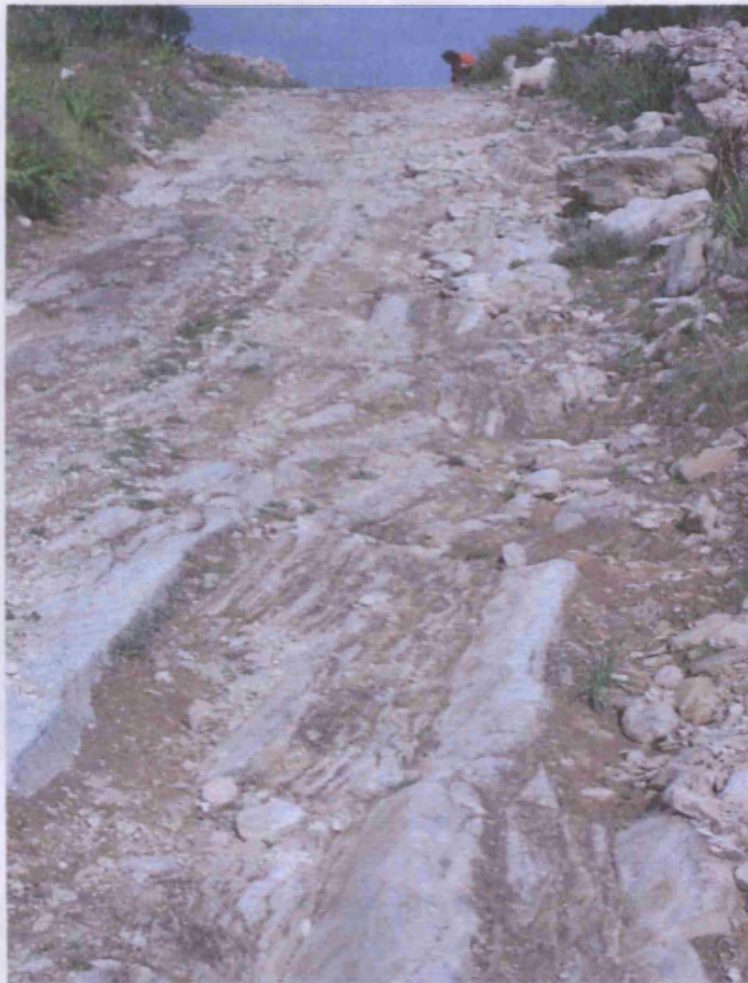
Fig.3.10: laminated gypsum or balatino outcrop, Plouti, Messara

Fig.3.10: laminated gypsum or balatino outcrop, Plouti, Messara

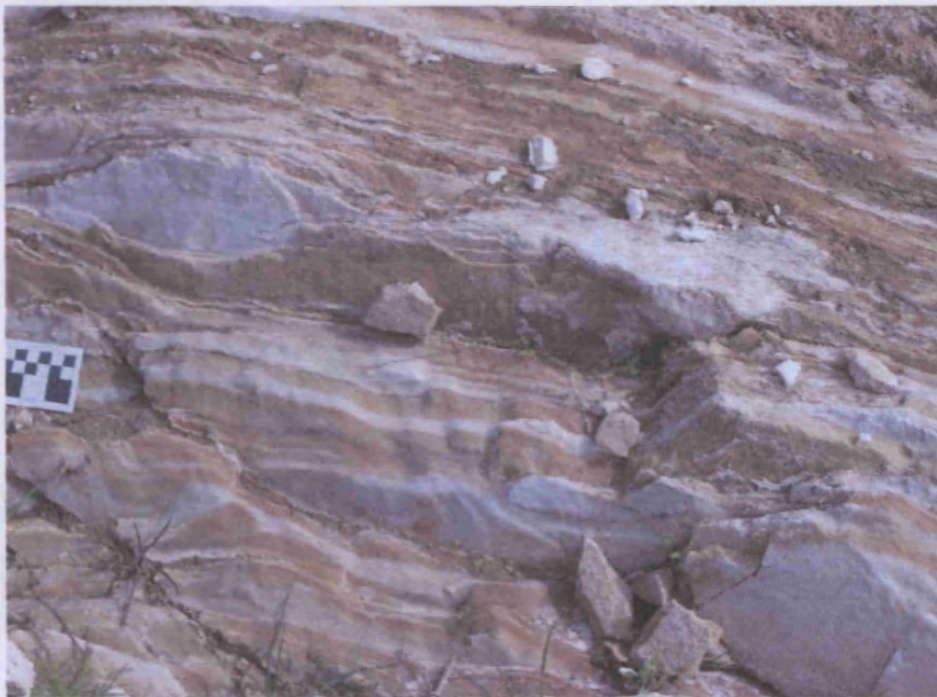
Fig.3.11: laminated gypsum at the outcrop of Plouti, Messara

Fig.3.11: laminated gypsum at the outcrop of Plouti, Messara

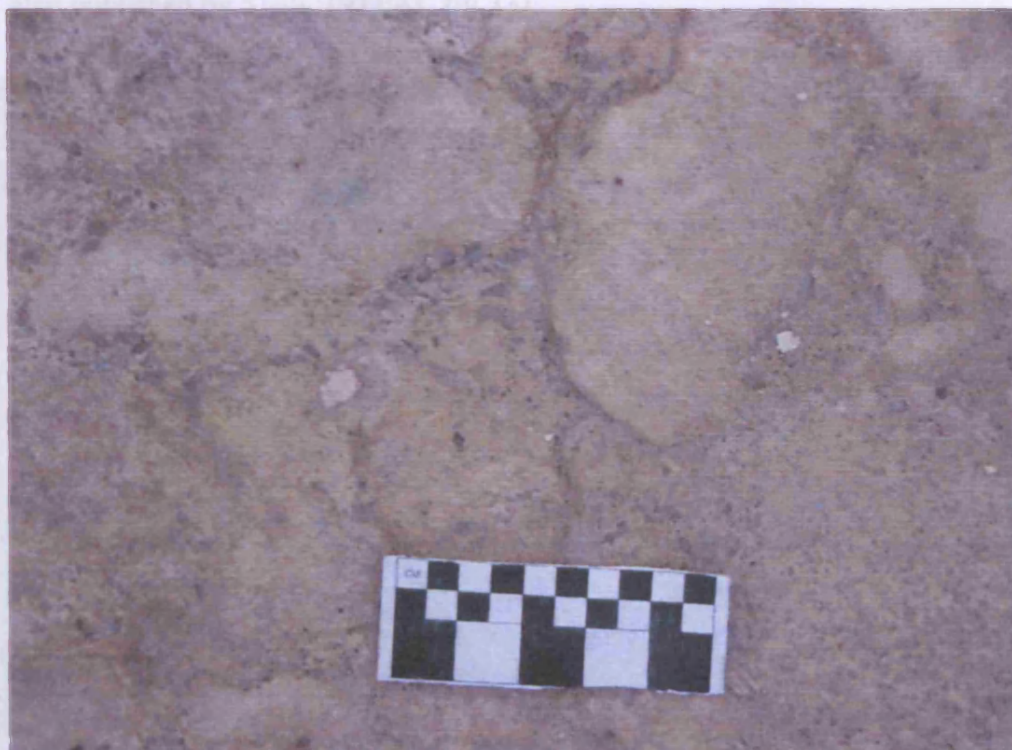
Fig.3.13: chaotic gypsum slab used in Levi's restorations at Phaistos, Room 50

Fig.3.13: chaotic gypsum slab used in Levi's restorations at Phaistos, Room 50

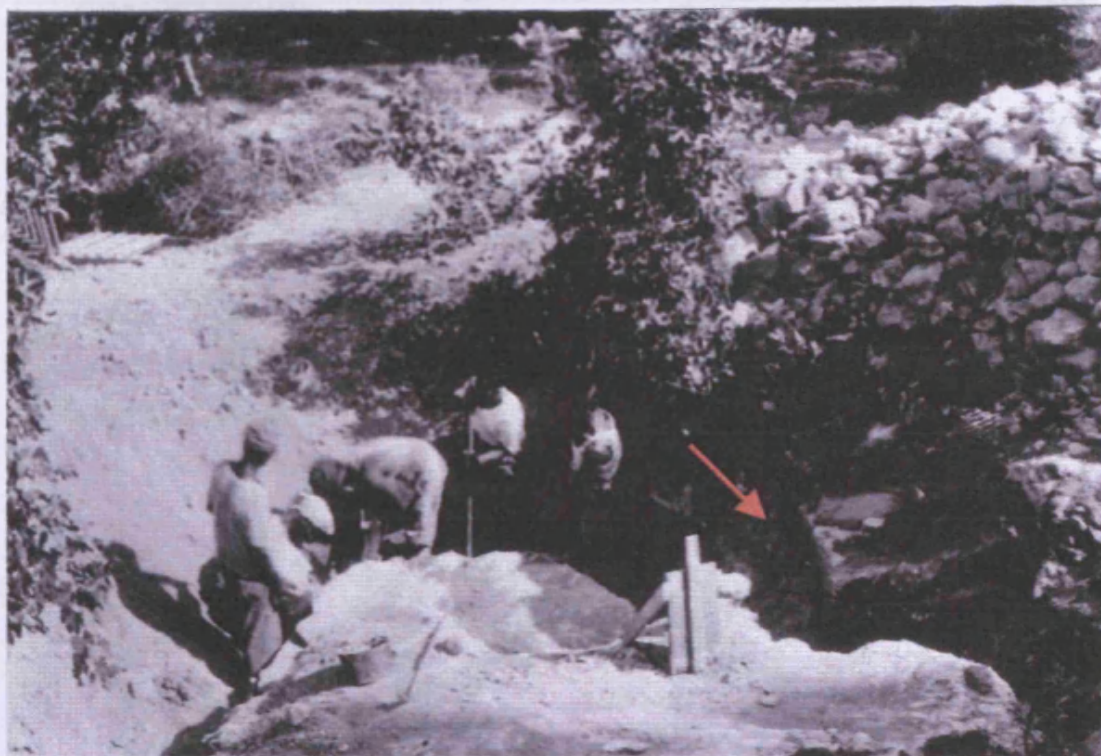
Fig.3.14: Levi's modern quarrying operations at the Minoan quarry of gypsum at Agia Triada, (photo courtesy of the Italian School of Archaeology No1149, also published by Shaw:1973:43, fig.33)

Fig.3.14: Levi's modern quarrying operations at the Minoan quarry of gypsum at Agia Triada, (photo courtesy of the Italian School of Archaeology No1149, also published by Shaw1973:43, fig.33)

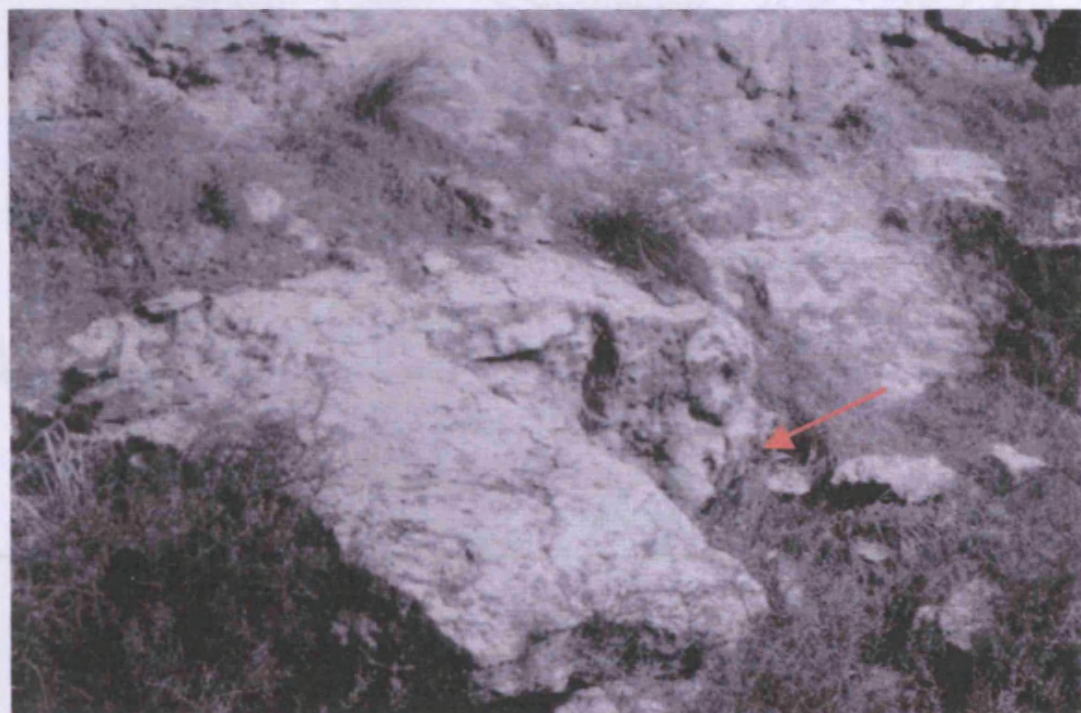
Fig.3.15: Minoan quarry of Agia Triada (photo taken By P.Betancourt in 1983)

Fig.3.15: Minoan quarry of Agia Triada (photo taken By P.Betancourt in 1983)

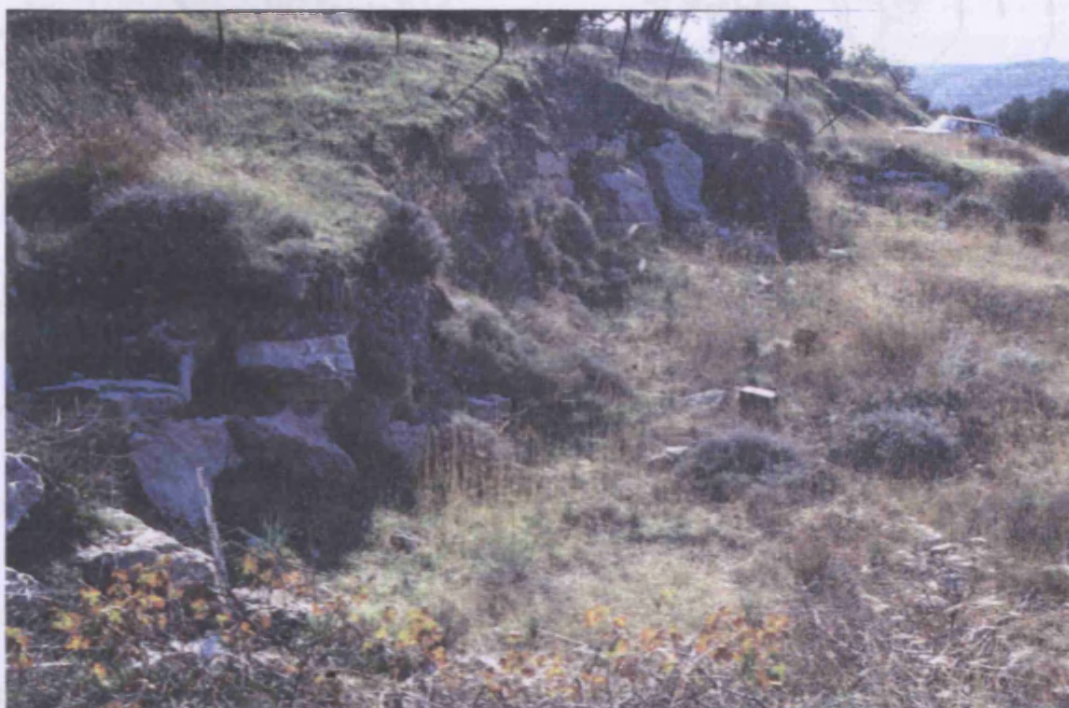
Fig.3.17: the location that has been pointed out by Evans' as the opening of the gypsum quarry with subterranean extension

Fig.3.17: the location that has been pointed out by Evans' as the opening of the gypsum quarry with subterranean extension

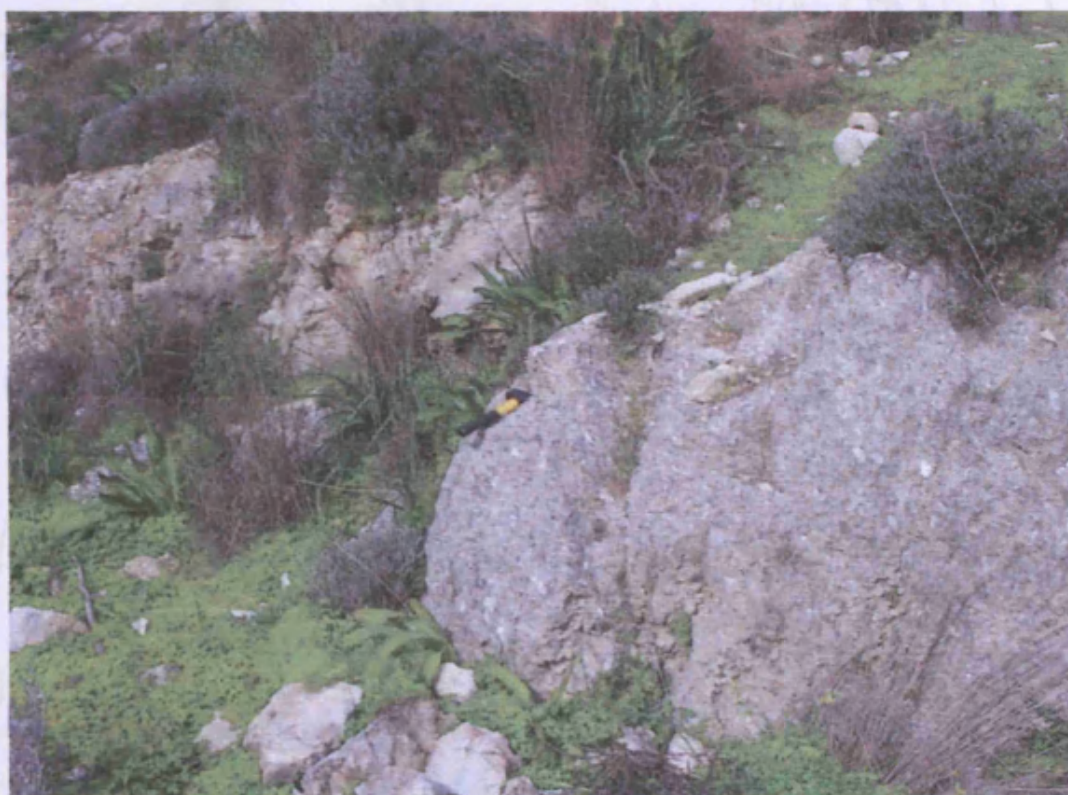
Fig.3.18: nodular and lenticular (left) and massive selenite (right) at Evans' gypsum quarry

Fig.3.18: nodular and lenticular (left) and massive selenite (right) at Evans' gypsum quarry

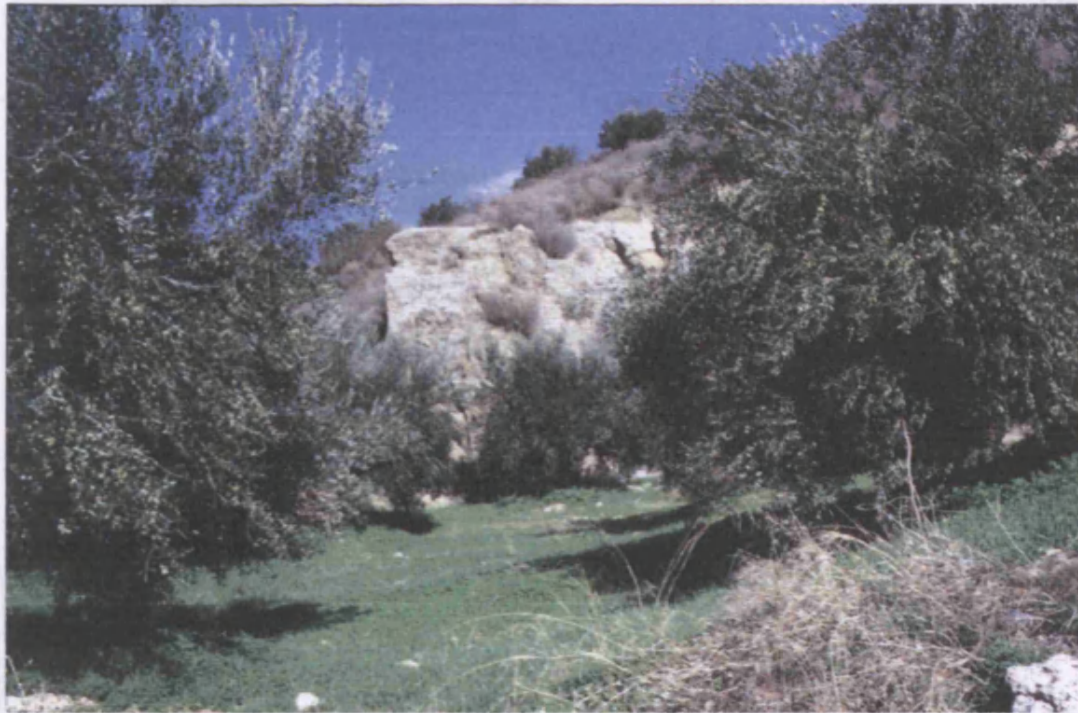
Fig.3.20: outcrop of massive selenite at Gypsades, possibly quarried in Minoan times, marked as LC1 in Fig.3.19

Fig.3.20: outcrop of massive selenite at Gypsades, possibly quarried in Minoan times, marked as LC' in Fig.3.19

Evans's quarry with subterranean extension (locus 303 in Hood's plan, shown in Map 3.6) is only 350m away (down hill) from the building site and the transportation of gypsum from that source would not be very difficult. However, as already explained, it does not seem that the massive selenite that was used for the orthostates of the west façade and other structural members was extracted from this area. It seems more possible that the nodular and lenticular selenite and laminated gypsum of the palace, that are much less in volume were extracted from that source while the massive selenite was extracted from LC2, which is almost 1km away from the building site and perhaps from LC1, even further, almost 1.3km away (Fig.3.19).

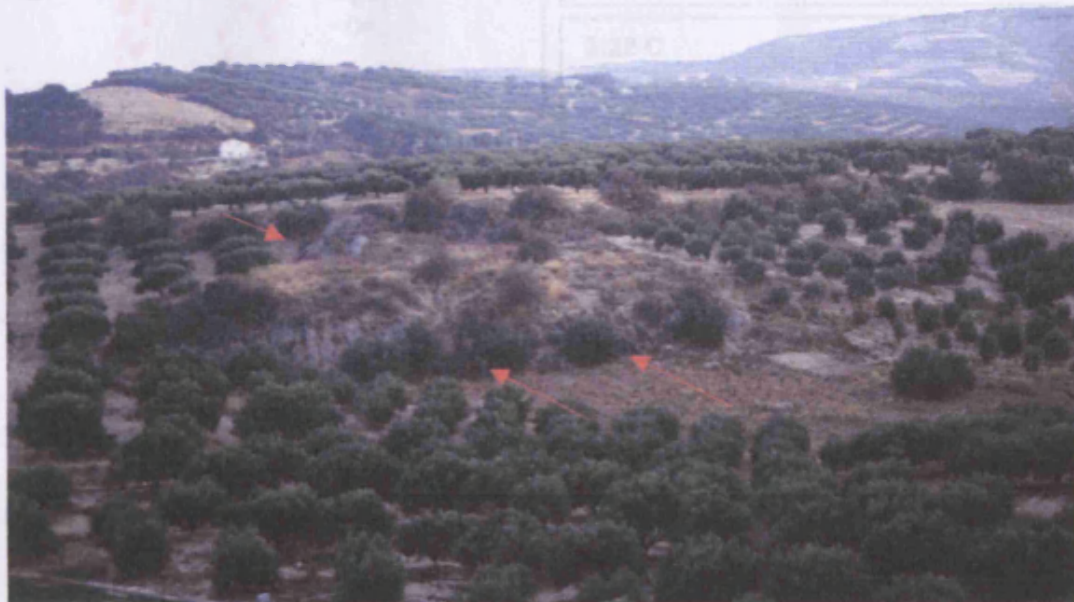
Fig.3.21: outcrop of massive selenite at Gypsades, with two terraces possibly quarried in Minoan times, marked as LC2 in Fig.3.19

Fig.3.21: outcrop of massive selenite at Gypsades, with two terraces possibly quarried in Minoan times, marked as LC2 in Fig.3.19

The transfer of massive and probably banded selenite from the last two locations would have been a quite difficult task but we should not exclude the possibility of moving stone via the Kairatos river. The proposed quarrying site LC2 is located in a quite low and smooth terrain about 200-250m west of the river and at an altitude no more than 50m higher than the riverbed (Fig.3.19). It is therefore quite sensible to reconstruct a transport mode via the river. The consequent debate, though, is whether the river was navigable.

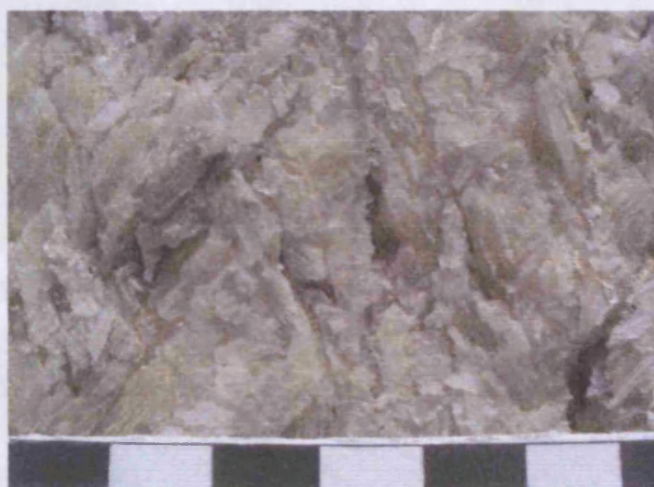
Fig.3.24: massive selenite cut parallel to the crystal growth

Fig.3.24: massive selenite cut parallel to the crystal growth

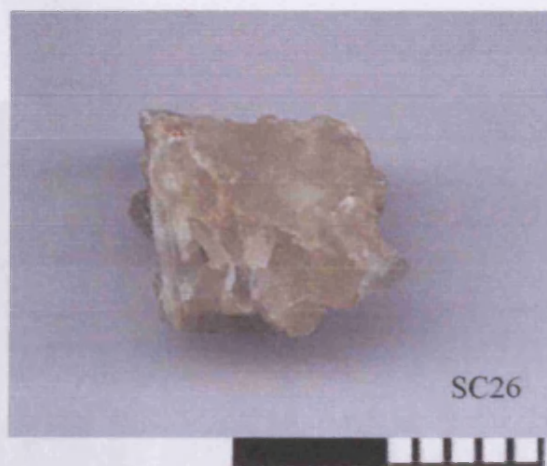
SC26: Unaffected selenite

Nirou Khani, Room 6, Floor Slab 17

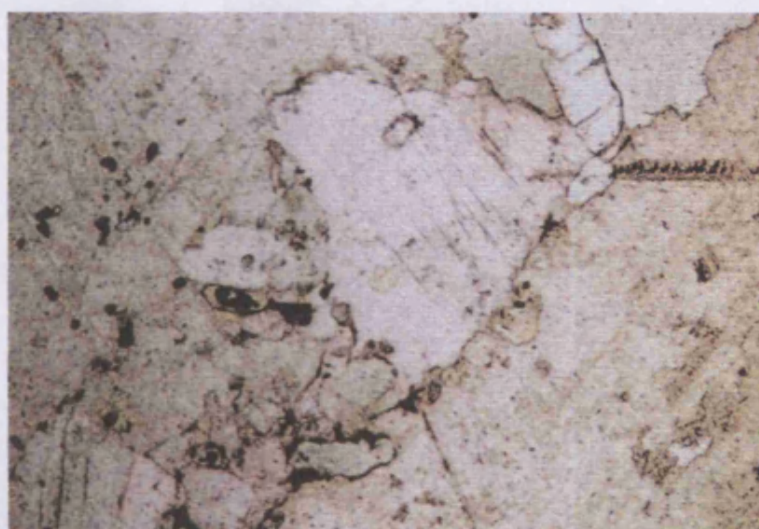
SC37: natural light 2.5x

SC37: Unaffected selenite.

Knossos Royal Magazines, Floor Slab 1072.

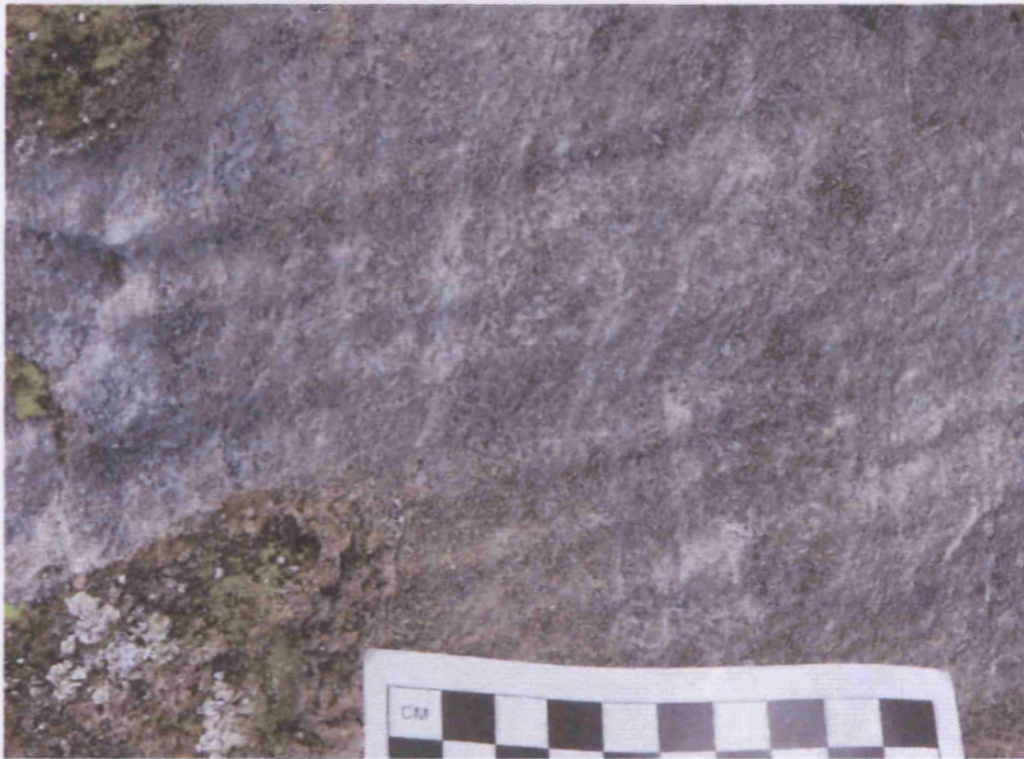
Fig.38: banded selenite, outcrop of Myrtos

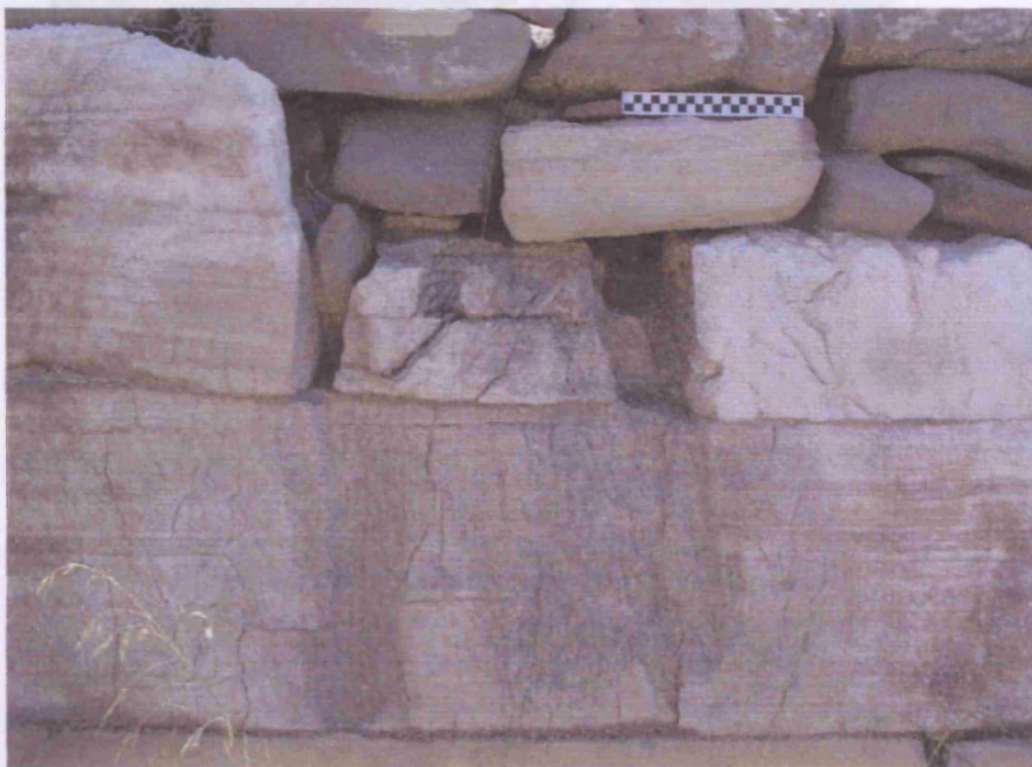
Fig.3.29: banded selenite ashlar blocks, east wall of light-well of Pyrgos

Fig.3.29: banded selenite ashlar blocks, east wall of light-well of Pyrgos

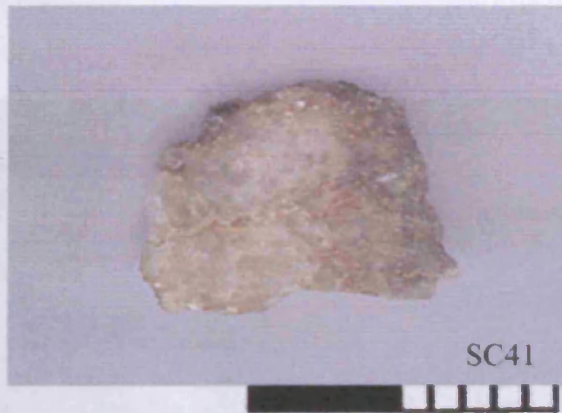
SC41: Unaffected fine selenite. Most crystals appear to be vertical.

Myrtos- Pyrgos, Loose fragment of fine grained selenite .

SC41: crossed polars 2.5x

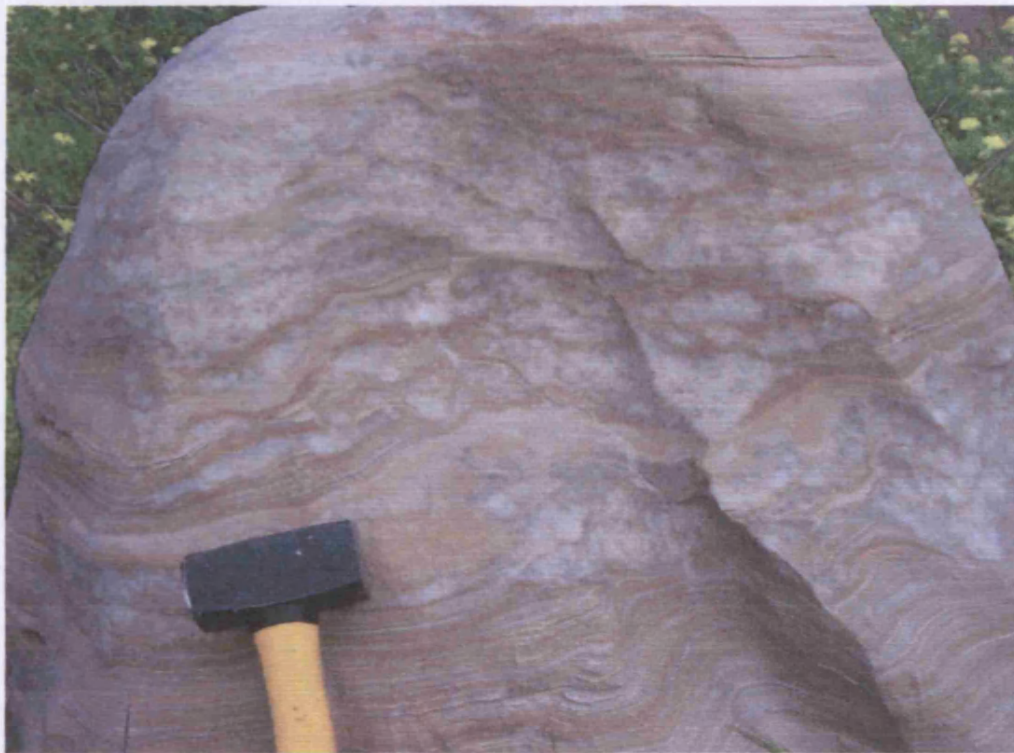
Fig.3.31: nodular and lenticular selenite, outcrop of Sarchos-Pyrgou

Fig.3.31: nodular and lenticular selenite, outcrop of Sarchos-Pyrgou

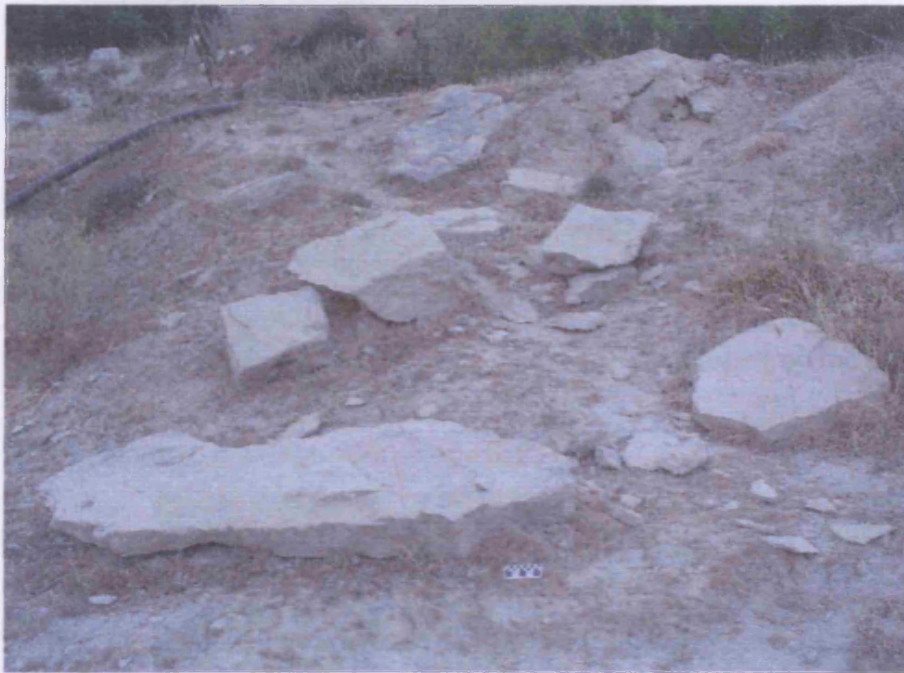
Fig.3.35: naturally separated blocks and slabs of nodular and lenticular gypsum, Foinikia

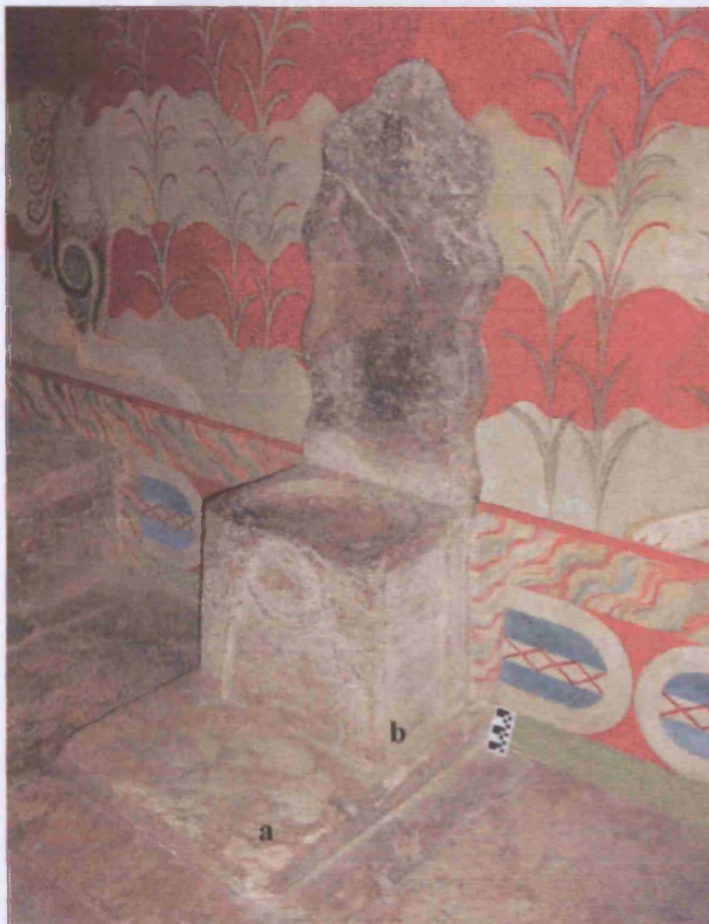
Fig.3.36: the Throne Seat at Knossos: the nodules of nodular and lenticular selenite are apparent on the horizontal surface of the slab that forms the base (a). The flaser-like arrangement of the laminations can be seen on the sides of the seat (b)

Fig.3.36: the Throne Seat at Knossos: the nodules of nodular and lenticular selenite are apparent on the horizontal surface of the slab that forms the base (a). The flaser-like arrangement of the laminations can be seen on the sides of the seat (b)

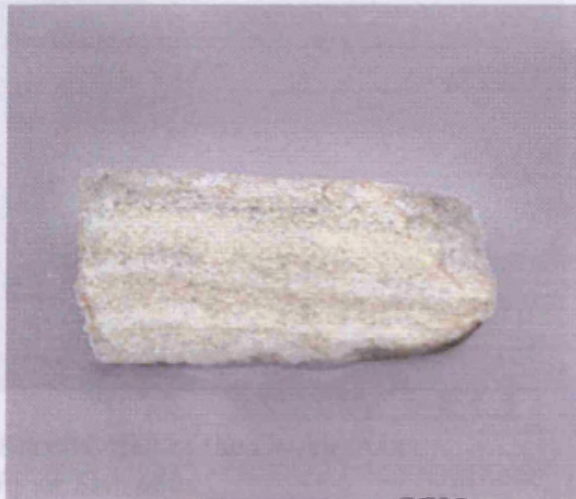
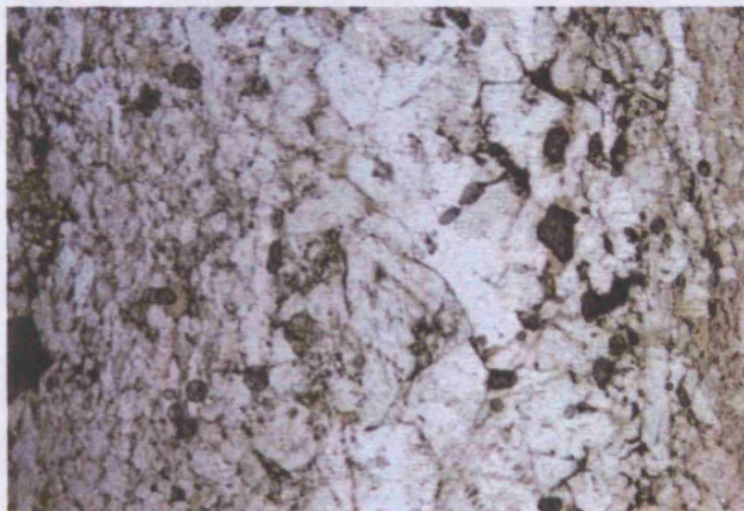
SC30: natural light 2.5x,

SC30: Unaffected laminated part of nodular and lenticular selenite with layer of elongated twin crystals, some of which are marked on the photo.

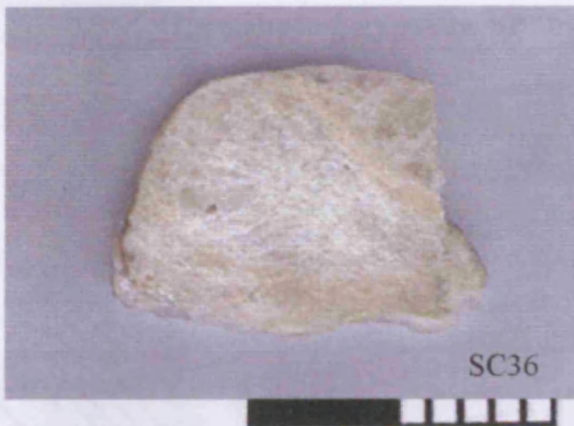
SC36: Unaffected nodular and lenticular selenite rock

Knossos, Hall of the Double Axes,
Floor Slab 666.

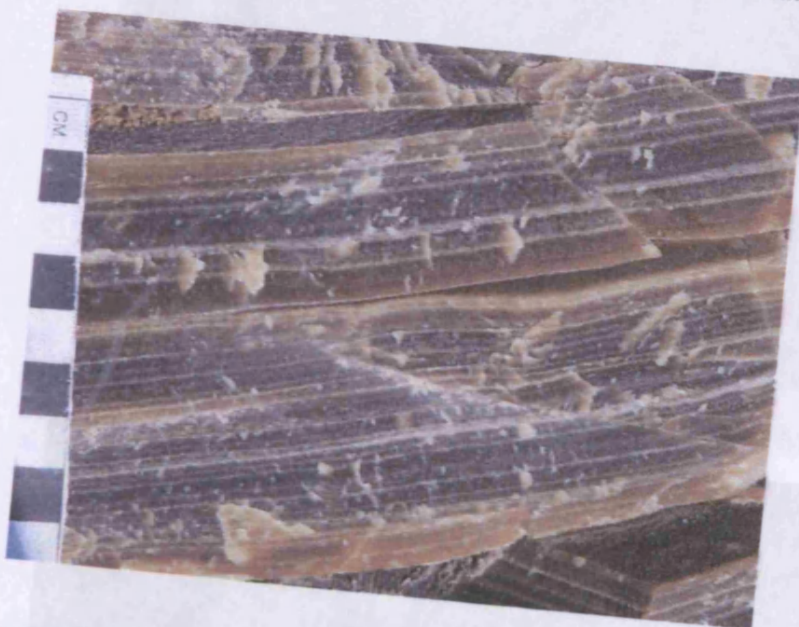
Fig.3.40: balatino cut vertically \perp to the laminations

Fig.3.40: balatino cut vertically l to the laminations

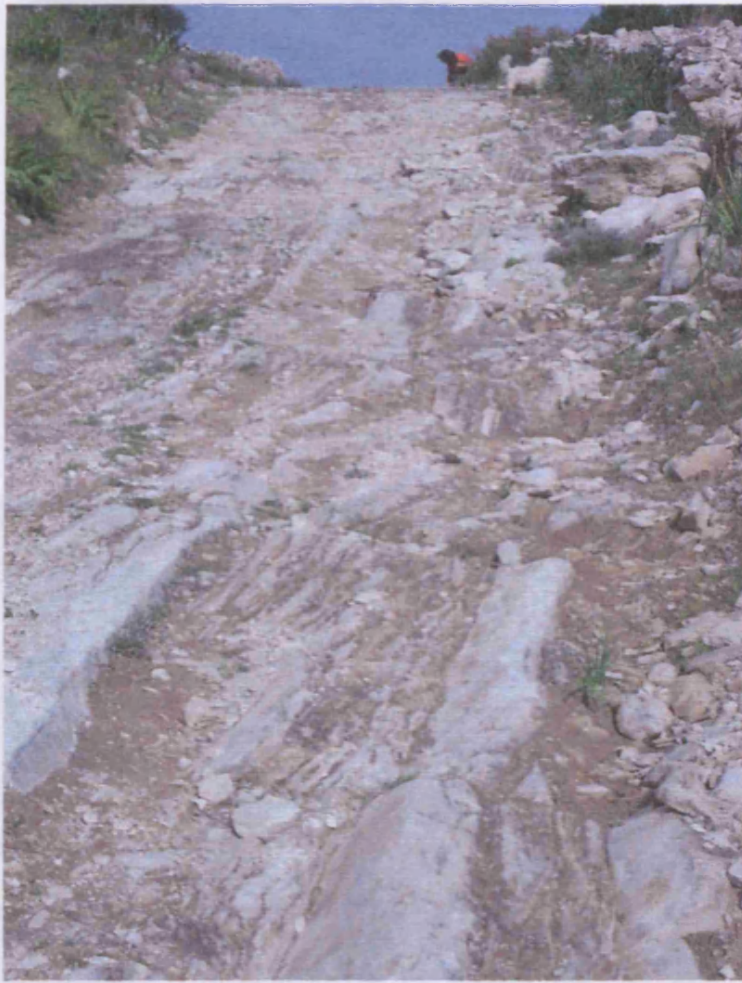
Fig.3.42: laminated gypsum or balatino outcrop, Plouti, Messara

Fig.3.42: laminated gypsum or balatino outcrop, Plouti, Messara

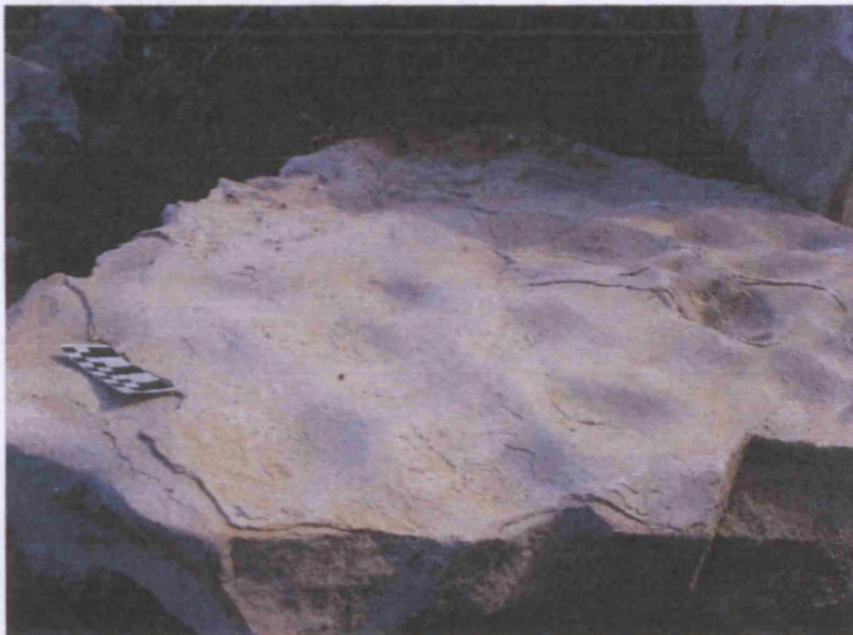
Fig.3.43: naturally separated slab of balatino, Plouti, Messara

Fig.3.43: naturally separated slab of balatino, Plouti, Messara

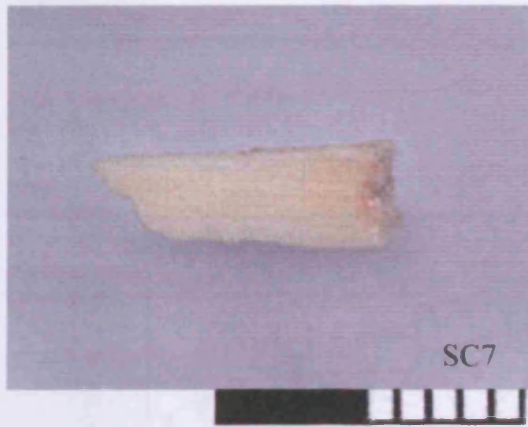
SC7: Messocrystalline idiotopic material with elongated twins crystals ($2\text{mm} > g > 0.06\text{mm}$). It could be the material from which the structures of the previous samples have derived, after dehydration -rehydration.

Phaistos, Hall 50, Floor Slab 266

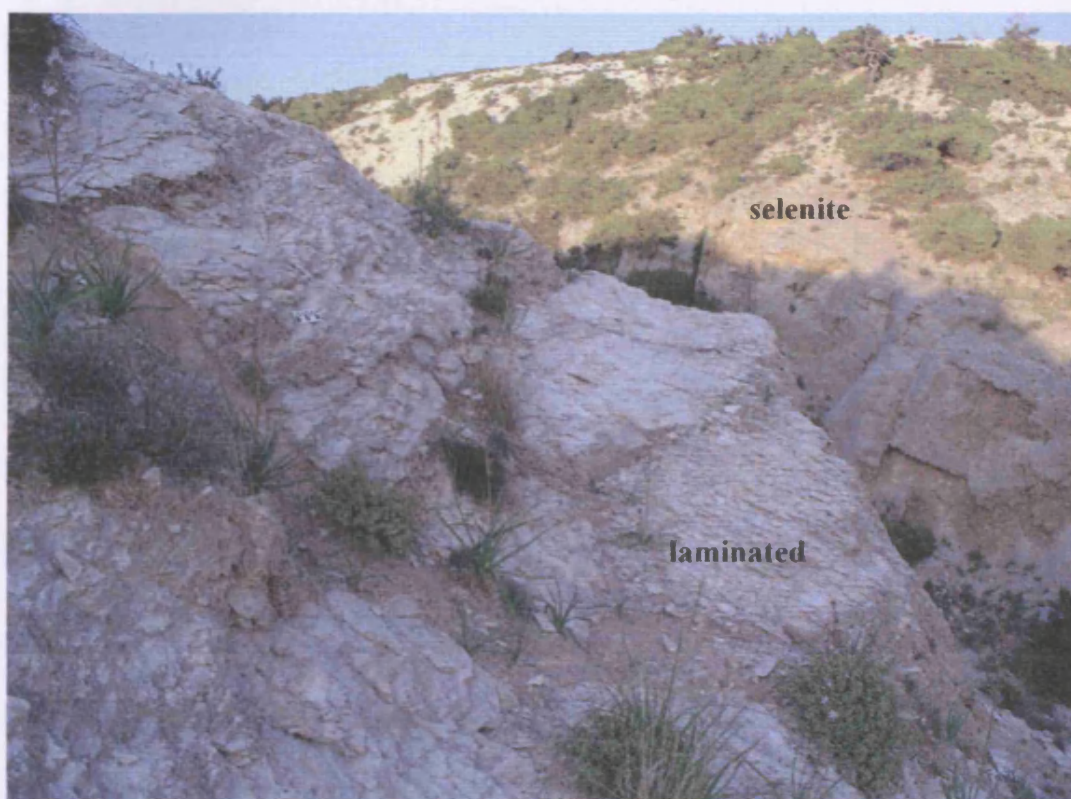
Fig.3.51: the outcrop of Myrtos with laminated gypsum on the hill at the front and selenite on the second hill at the back

Fig.3.51: the outcrop of Myrtos with laminated gypsum on the hill at the front and selenite on the second hill at the back

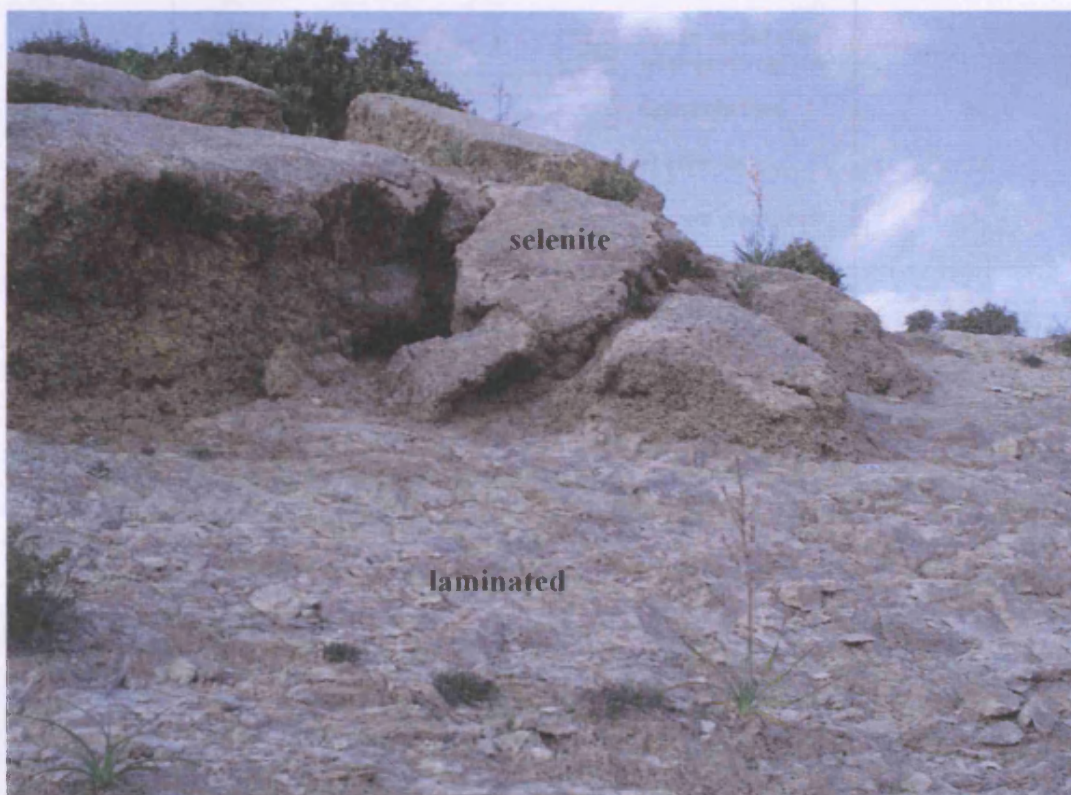
Fig.3.52: the outcrop of Myrtos with selenite above laminated gypsum

Fig.3.52: the outcrop of Myrtos with selenite above laminated gypsum

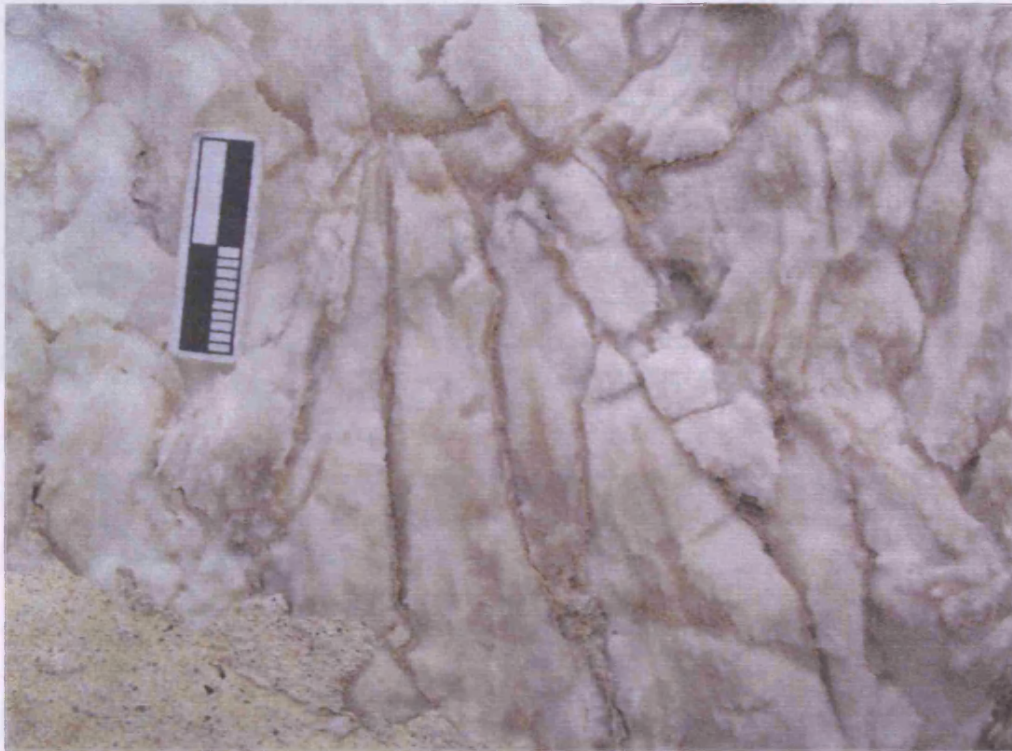
Fig.3.53: pseudomorphs of former massive selenite, Knossos, Magazine VII

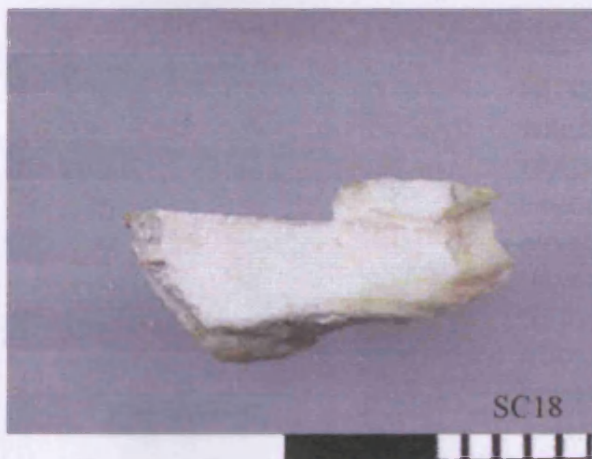
Sample 18: Pseudomorphs after selenitic crystal of which we can see distinctive structural characteristics such as the former cleavage planes and the step shaped crystal boundaries. Dehydration and re-hydration of the sample has resulted in a re-crystallization of the material in a granular microcrystalline structure. The secondary crystals are oriented along parallel lines that resemble the cleavage planes of the original selenitic crystal and correspond to their step shaped edges.

Nirou Khani, Loose Slab 418.

— Step shaped crystal boundary
— Former cleavage planes

SC18: crossed polars 2,5x.

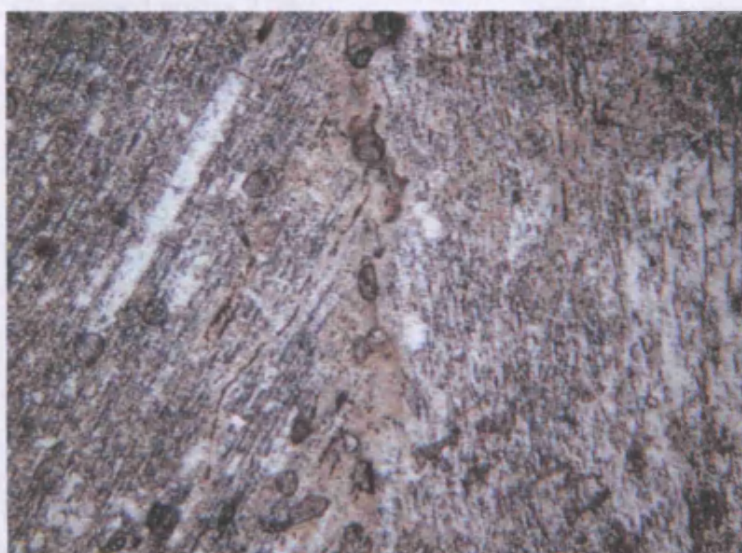
SC18: natural light 2,5x.

Fig.3.55: stepped shape crystal boundaries in selenitic pseudomorph. Elongated cloudy ameboid gypsum crystals are marking the former cleavage planes of the selenite crystal
